Structural Component Testing of the Saab JAS 39 Gripen E/F

Presentation FT2019

Martin Ekström
Saab Aeronautics October 8th, 2019

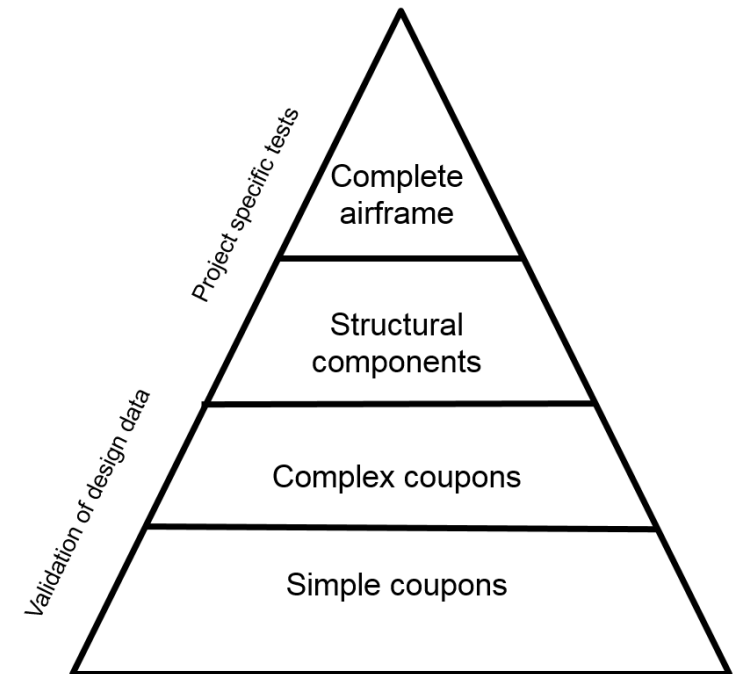
Pyramid of tests

- **Simple coupons**, materials basic testing
- **Complex coupons**, simplified sample with multiple parts
- **Structural Components**, important components with complete surroundings
- **Complete Airframe Tests**

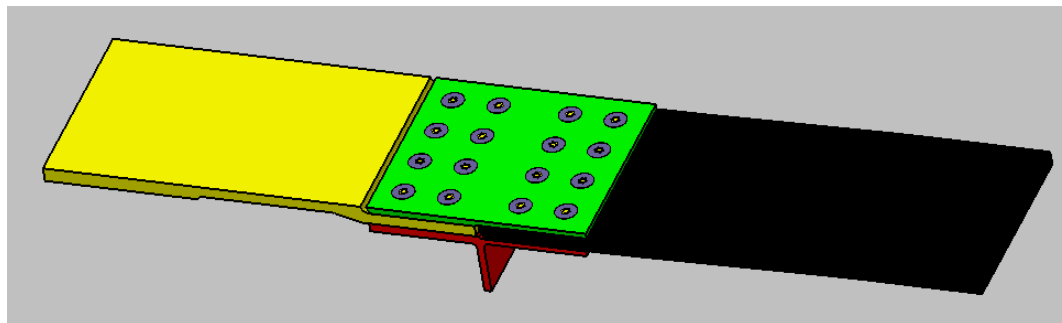
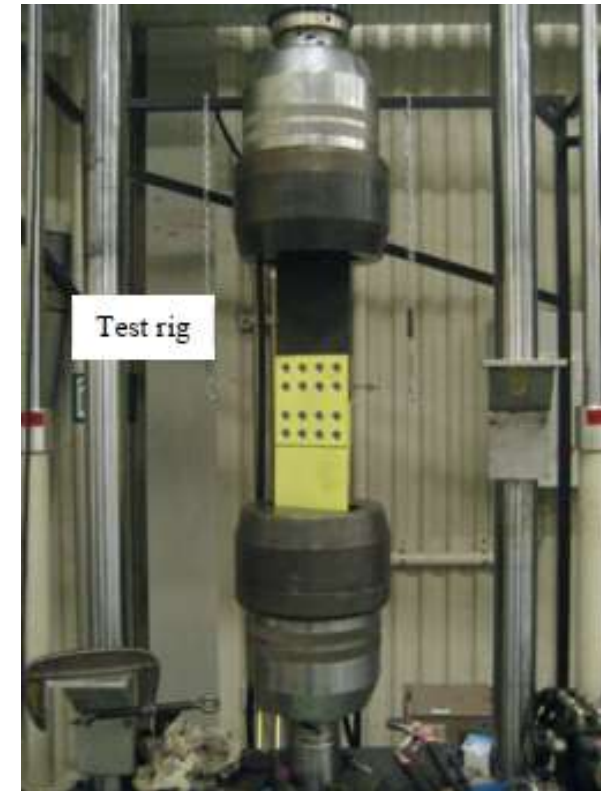
→ Simplified wing joint development tests

- Static
- Fatigue
- Damage Tolerance
- Several joint designs
- Two materials (AA2050 and AA7050)

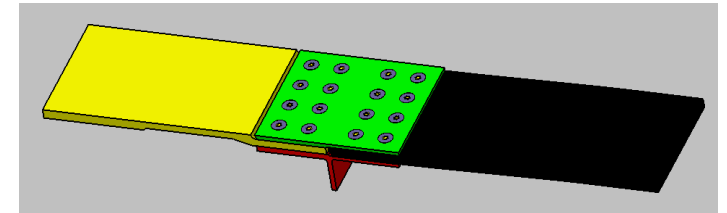
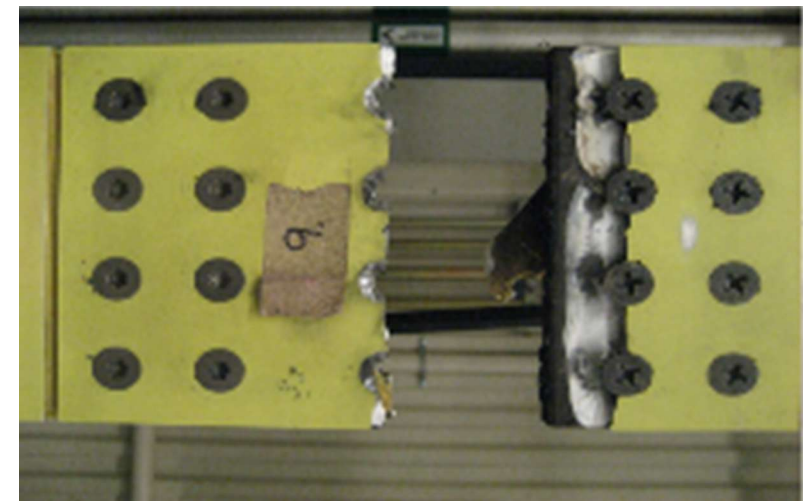
→ Simplified wing joint development tests, results

- Two materials (AA2050 and AA7050)
- Two geometries
- Detailed FE-analyses of stresses and strains
- Results
 - Static test to failure (>220 % Limit Load)
 - Fatigue test to failure (withstand >4 Design Life)
 - Damage tolerance test to failure (withstand >3 Design Life)
 - This means that the requirements were met
- Failure in metallic parts

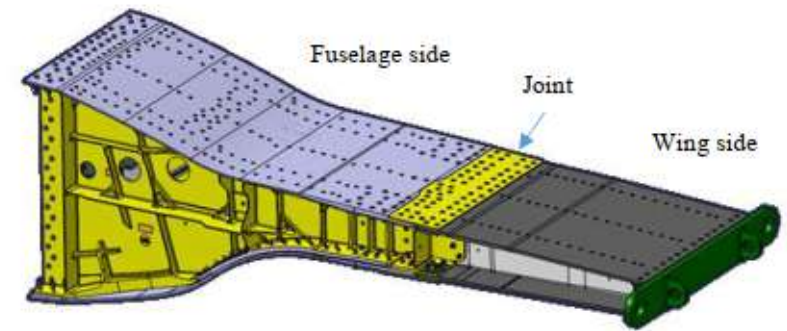
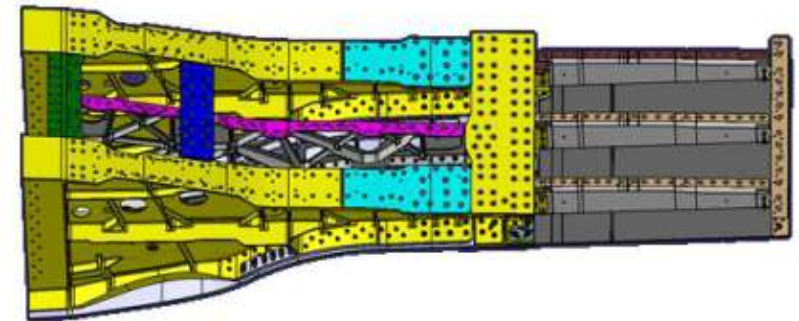
Wing to fuselage joint testing

- To verify the structural integrity regarding both static strength and damage tolerance capability of the wing-fuselage joint

- New design principle
- Continuous joint with screws
- New materials
- Upgraded criticality

- One specimen for static loading
- One specimen for damage tolerance testing with artificial defects

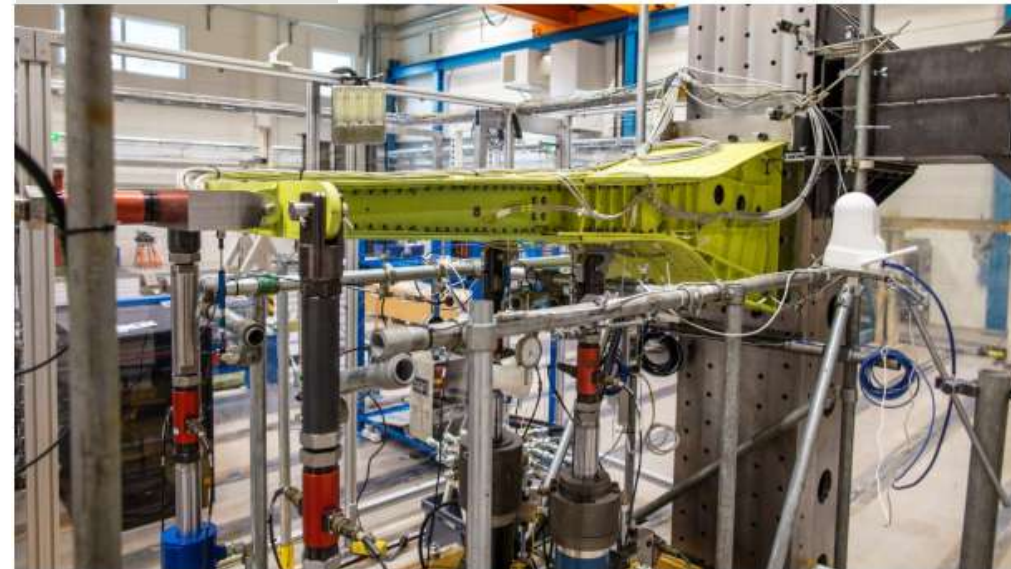
- Test has been completed without any deviations from expected results
- At the end of the test, artificial defects were introduced both in the metallic and the composite parts
- This means that the requirements were met

Specimen 1 in test rig.

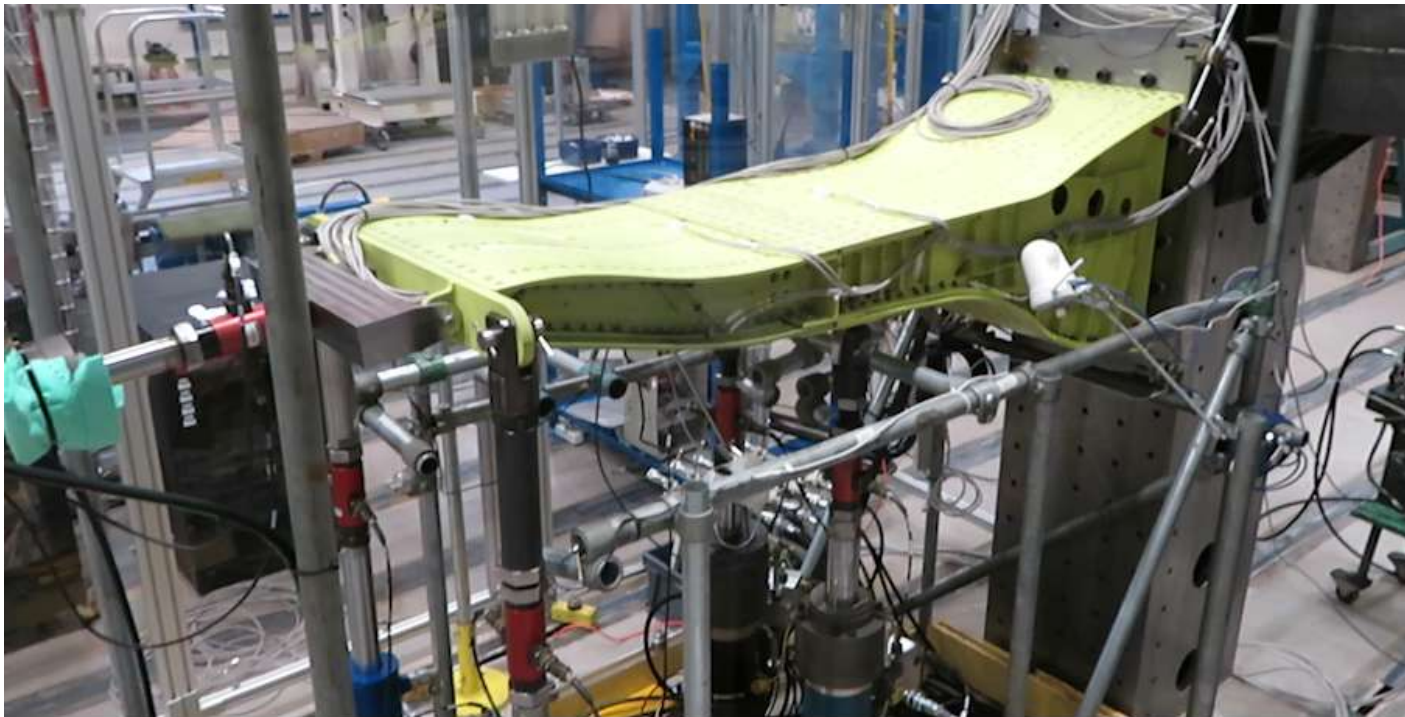
→ Static test, after testing to failure

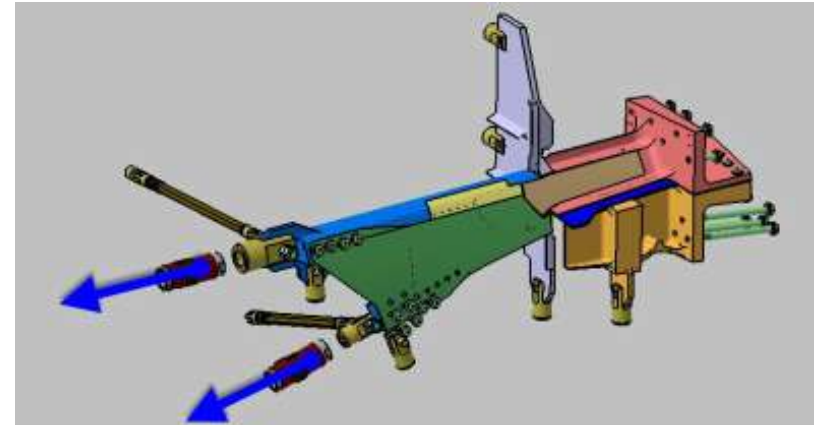
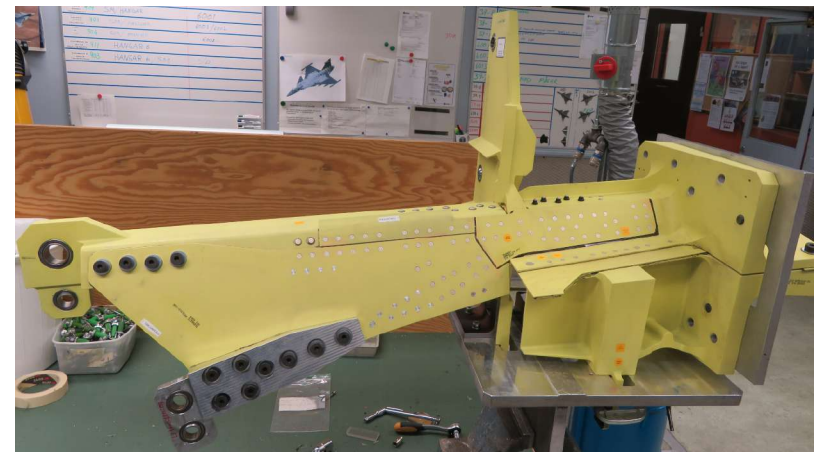
Canopy sill to stringer testing

- To verify the rail joint at the frame between the Forward Fuselage and Gun Section against fatigue and damage tolerance

- New design principle
- New materials
- Upgraded criticality

- Specimen 1: Fatigue testing
- Specimen 2 and 3: Damage tolerance testing

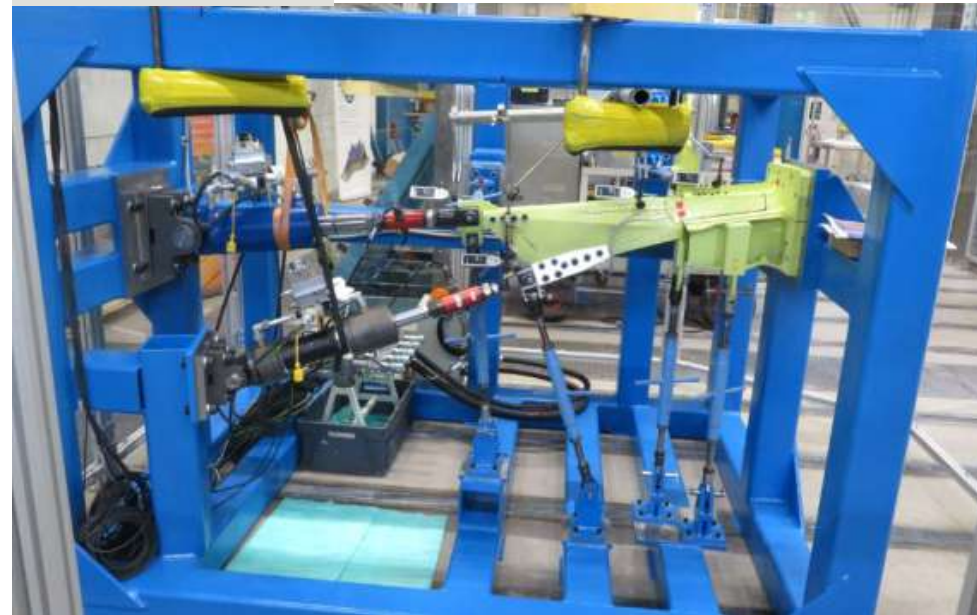
- Fatigue test: (Specimen 1)
 - Test has been completed without any deviations from expected results
 - After ordinary testing, the load was increased with 20% DSL
- Damage tolerance test: (Specimen 2 and 3)
 - Totally artificial 18 defects are introduced, mainly at fastener holes
 - The test has just started for specimen 2

Specimen 1 in test rig.

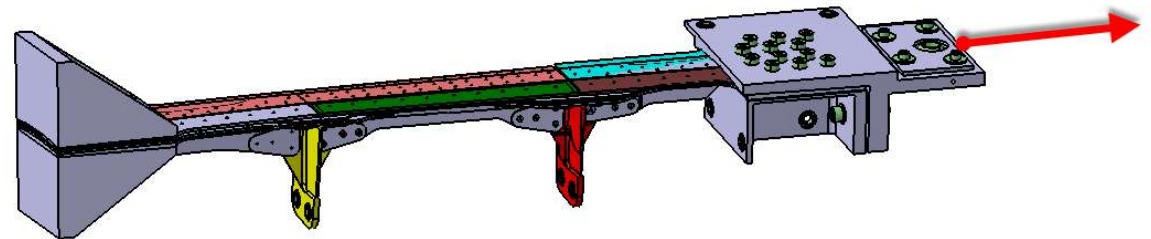
Stringer joint behind 8390 testing

- New design
- Upgraded criticality

- Specimen 1: Fatigue testing
- Specimen 2 and 3: Damage tolerance testing

Test specimen.

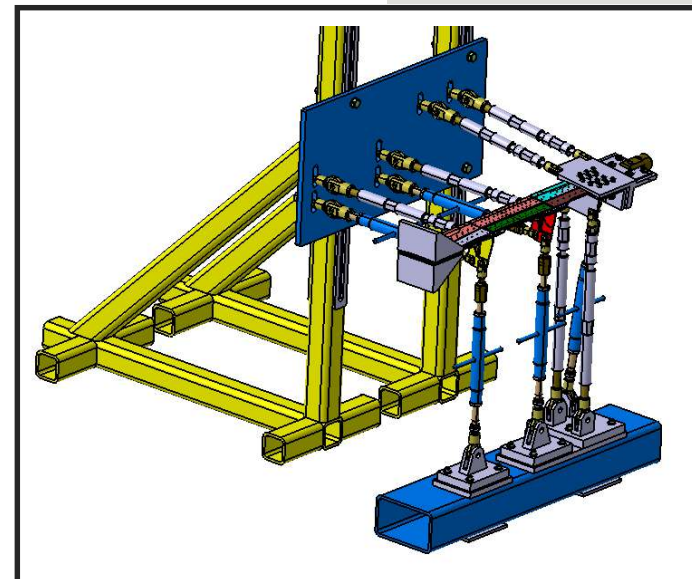
Specimen in test rig.

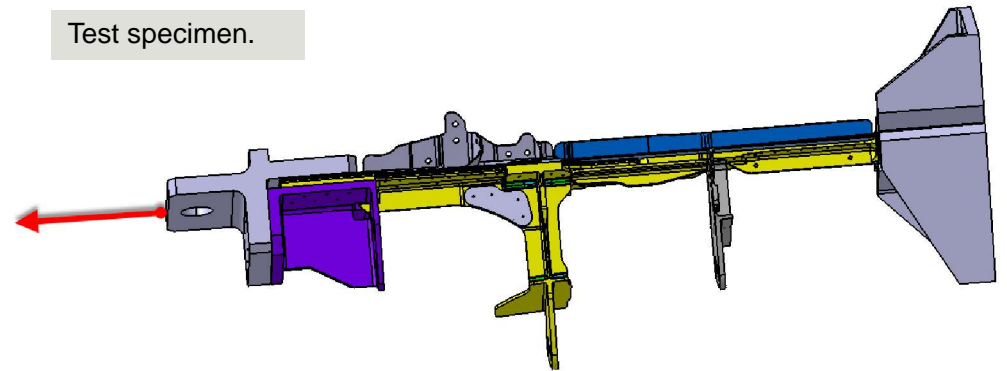
Stringer joint behind 11770 testing

- New design principle
- New materials
- Upgraded criticality

- Specimen 1: Fatigue testing
- Specimen 2 and 3: Damage tolerance testing

Test specimen.

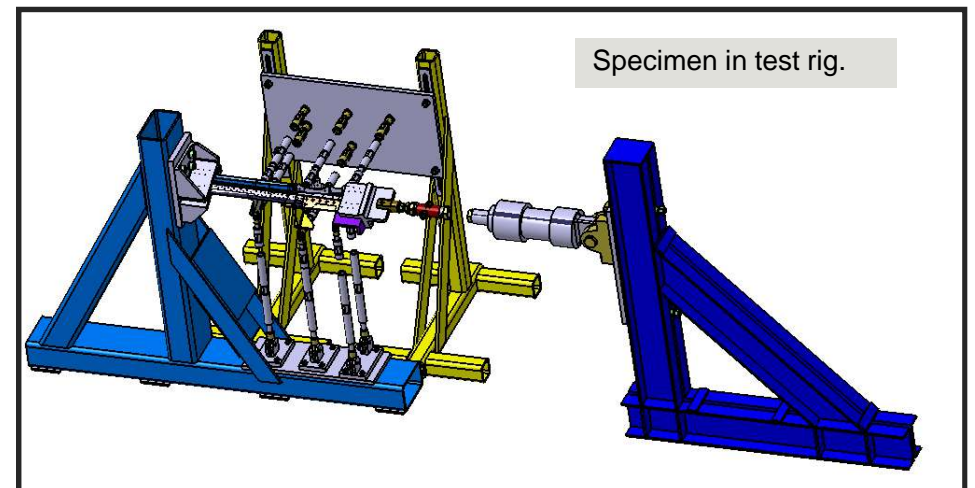
Specimen in test rig.

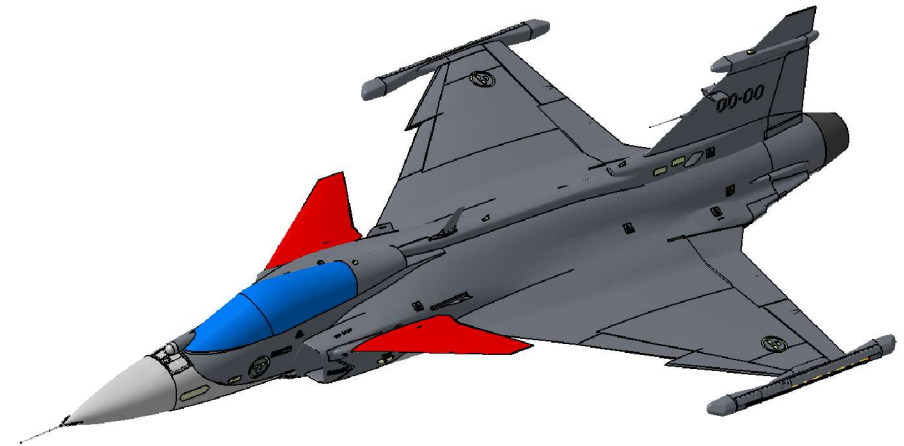
Canard wing with pivot testing

- New materials
- New load spectra
- One specimen (from ordinary production)
- Fatigue and Damage Tolerance Test
 - Without artificial defects
 - With artificial defects

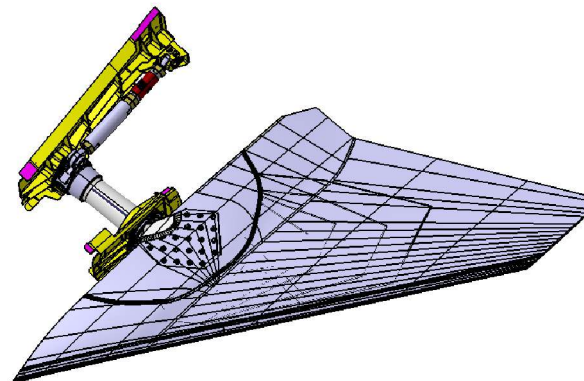
Test specimen.

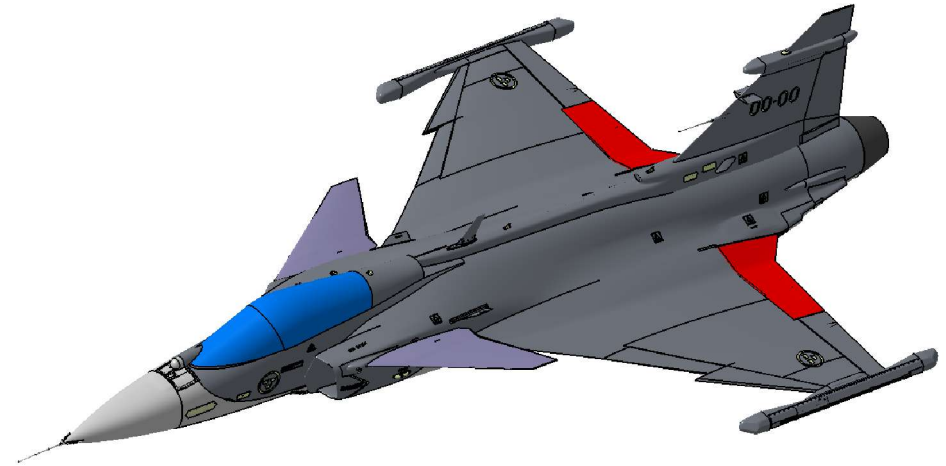
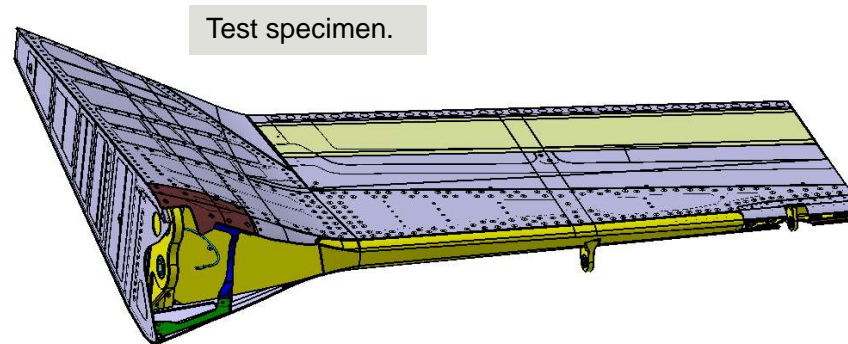
Inner elevon testing

- New materials
- New load spectra
- One specimen
- Fatigue and Damage Tolerance Test
 - Without artificial defects
 - With artificial defects

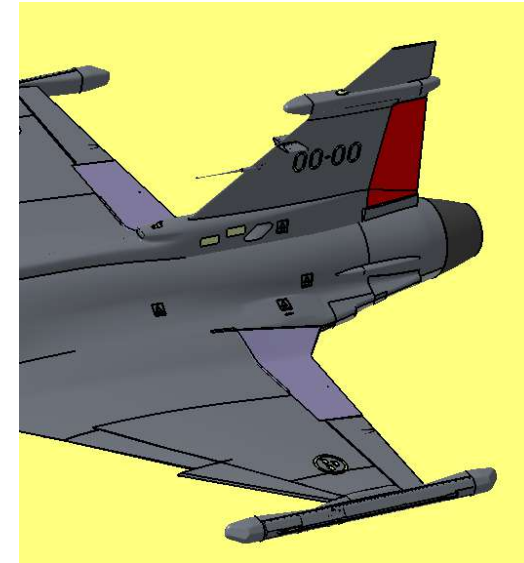
Rudder Testing

- New load spectra
- One specimen
- Fatigue and Damage Tolerance Test
 - Without artificial defects
 - With artificial defects

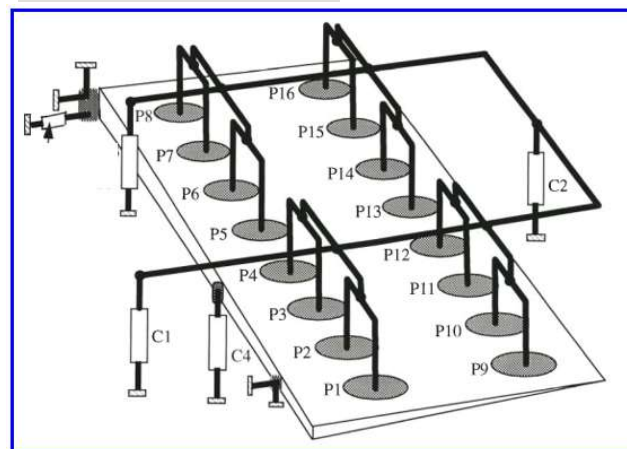
Test rig, schematically

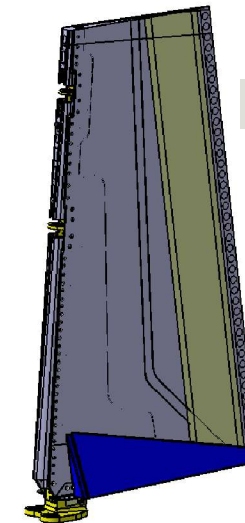
Test specimen.
