Bird Strike Testing of the Saab JAS 39 Gripen E

Presentation FT2019

Peter Årebo Saab Aeronautics / Etteplan Engineering Solutions October 8th, 2019

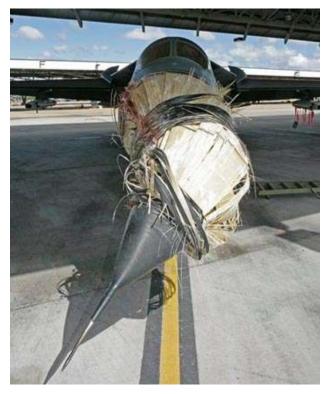
F-111 A8-112, collision with a pelican, Amberley 11th April 2008 Photo: Darren Crick, RAAF

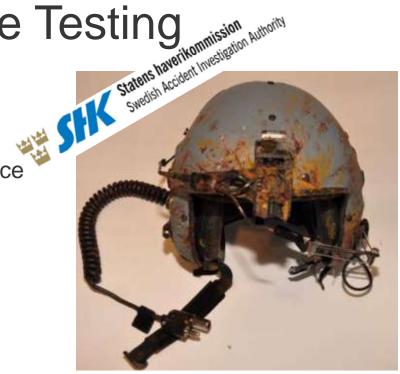
AW109 (Hkp 15) Collision with a wood grouse, Sveg 3rd February 2017, Photo: SHK

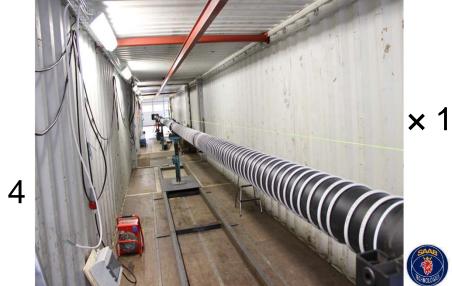
→ Test Set-Up:

- Data acquisition system:
 Dewesoft Sirius 64 channels 200 kHz
- Camera system:4 st Photron SA up to 20 000 fps
- Lighting system:4 st Gun-Lux LED Maxi Brut 1200
- Bird Strike Gun:
 Tempered barrel to 20°C
 Calibre 150 mm, 24 m long

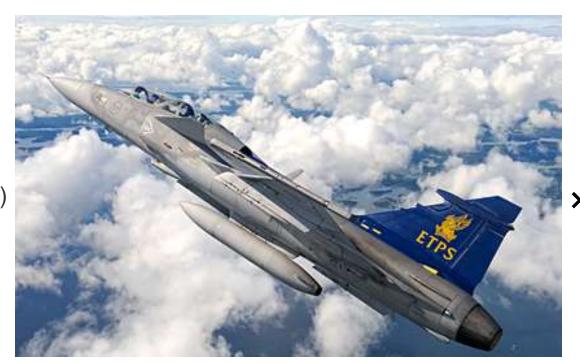
Test 7
MAW

- → MAW Test Object & Rig:
 - JAS 39-802
 - The last Gripen B to fly for the Swedish Airforce
 - Has flown for Empire Test Pilots' School (ETPS) of the UK
 - Scrapped fuselage used for previous testing
- → Slight modifications made to interfaces to accommodate the Gripen E Air Intake & Gripen C Canard

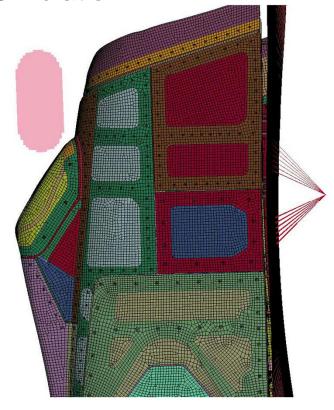
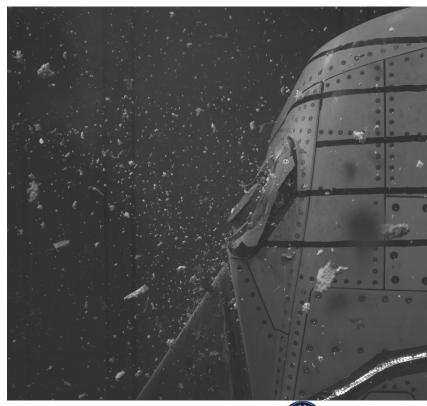
→ Results: Film vs. Simulation

LS-DYNA keyword deck by LS-PrePost Time = 0

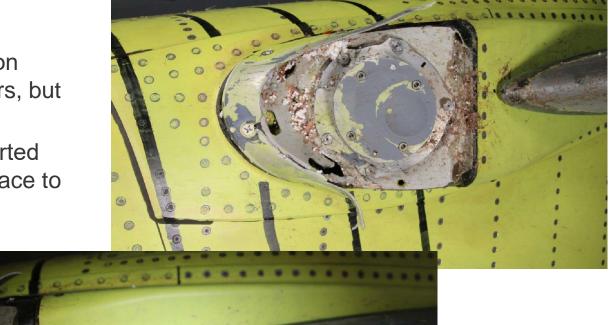
→ Results:

A bird strike to the MAW installation causes large damage to the covers, but no penetration into the air duct.

The released debris is safely diverted away from the fuselage and interface to the Canard.

Only scratches caused on the Canard leading edge.
