Multilayered Thermal Barrier Coatings processed by Suspension Plasma Spraying

Satyapal Mahade, Per Nylén

Department of Engineering Science, University West, Sweden

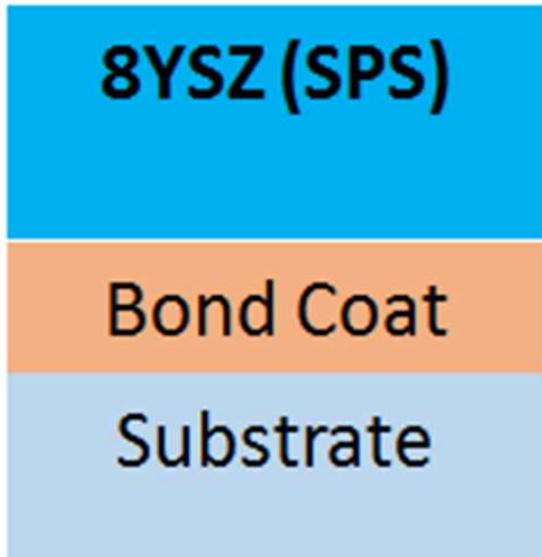
SPS processed 8YSZ

Different TBCs sprayed by suspension plasma spray process

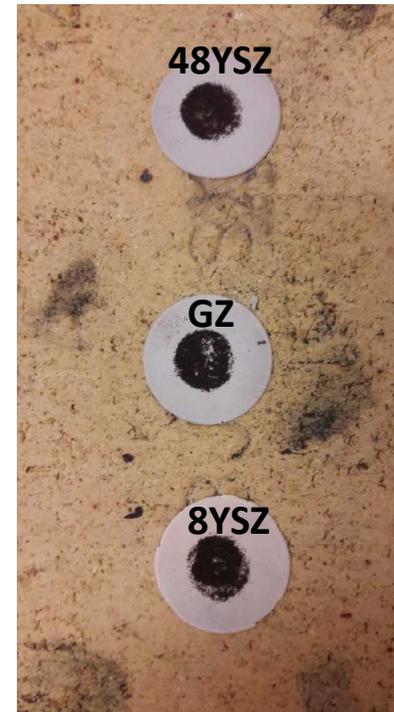
Before test

- Isothermal test conditions were used
- 20 mg of the (Laki) ash was applied over an area 1cm^2
- Temperature of exposure was 1250°C
- Time of exposure was 1 hour
- Free standing coatings were approximately $550\ \mu\text{m}$ thick

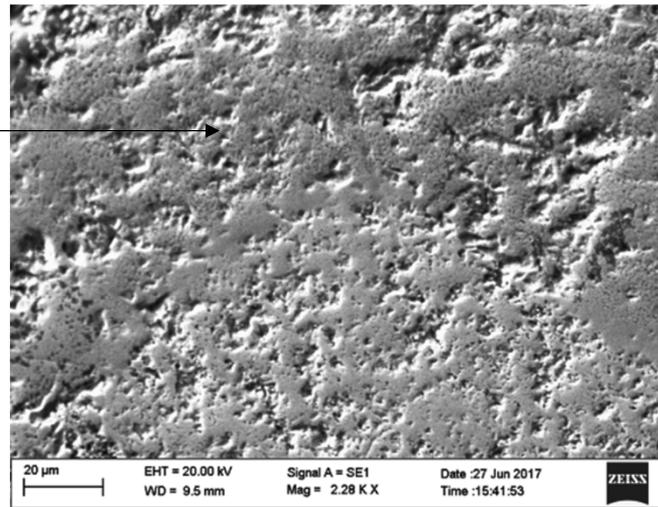
GZ after VA infiltration

- VA infiltration depth for GZ based TBC was ~80 μm
- The VA was arrested near the surface of GZ TBC
- The elemental maps (EDS) detected Si, Fe and Ca
- The infiltrated (smooth) and non infiltrated (porous) zones can be identified in the SEM micrographs
