Selective laser melting of Alloy 718

**Heat affected zone cracking in different heat-treated conditions of selective laser melted Alloy 718
subjected to gas tungsten arc welding**

PhD Student: Tahira Raza

Oct 2019

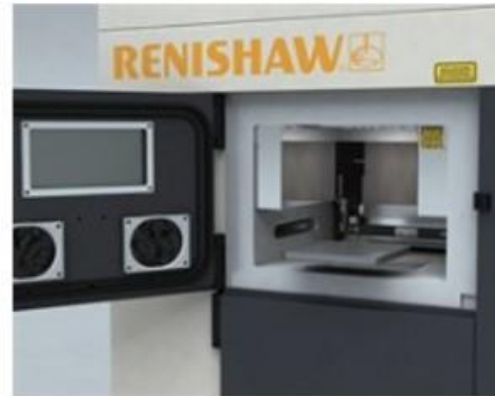
2. Build plate loaded

Build plate is loaded into the system chamber and secured.

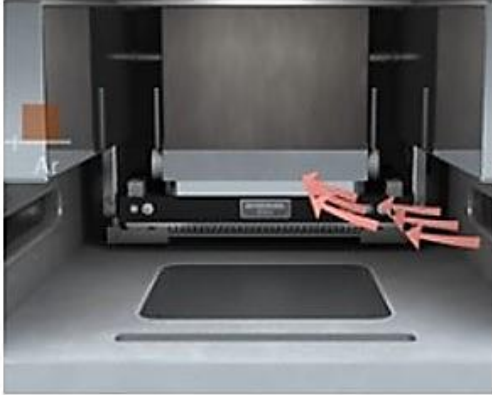
5. Inert gas

Chamber is filled with argon inert gas - class leading low gas consumption.

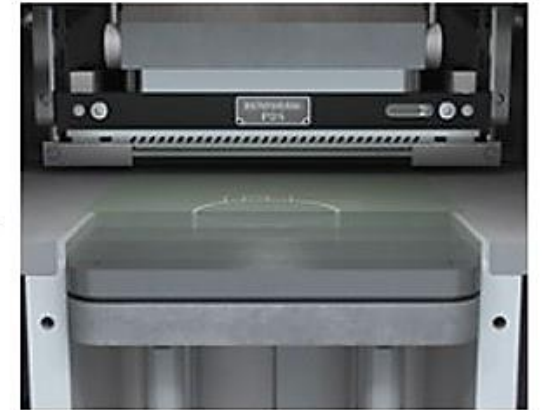
8. Building in layers

Build plate moves down and next layer is built up.

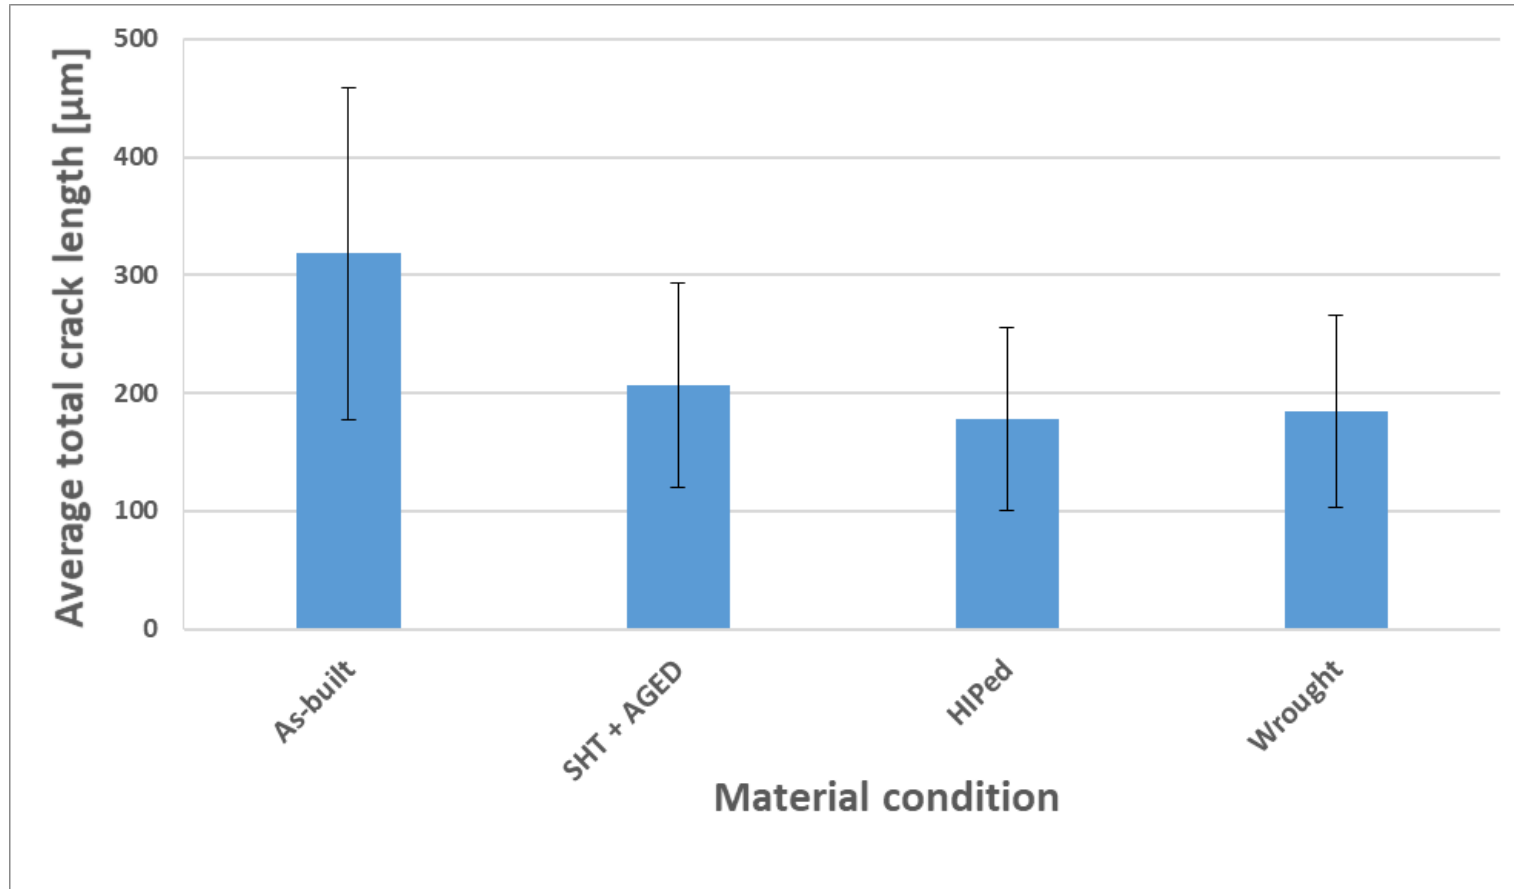
Heat affected zone cracking susceptibility of SLM-manufactured Alloy 718

- Total crack lengths in HAZ were **highest in the SLM as-built condition** and **lowest in the SLM hot isostatic pressed condition**.
- **As-built** Alloy 718 contained Laves phase and NbC carbides in interdendritic regions that caused the liquation of grain boundaries in HAZ during welding.
- After **solution + aging treatment**, the Laves phase was partially dissolved and extensive amount of delta phase was formed at grain boundaries.
 - Liquation of Laves phase and NbC carbides was the main cause of HAZ liquation cracking in this condition.
- After **hot isostatic pressing**, the cracking susceptibility of SLM-manufactured Alloy 718 became almost like **wrought** Alloy 718.
 - Constitutional liquation of NbC carbides was the main cause of HAZ liquation cracking in these condition.
